VERSAGUN PROBLEMS AND SOLUTIONS

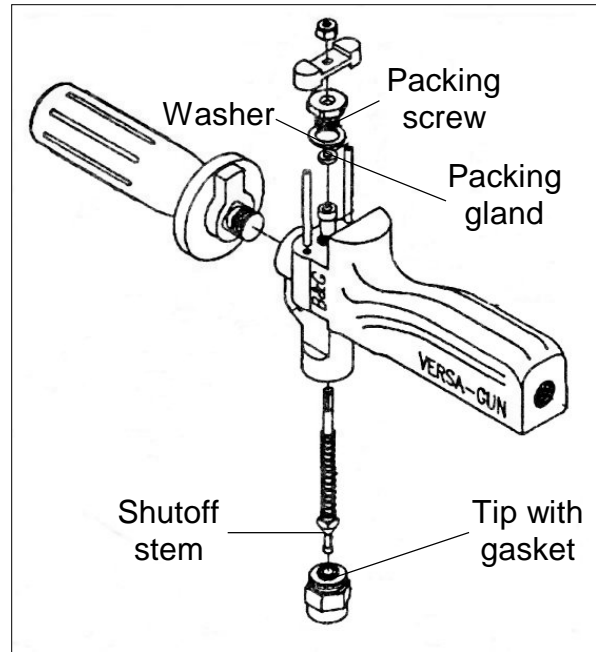
P. Gun is leaking at the junction with the soil rod.

S. Remove the soil pipe and tighten the tip to the gun.

If leak continues, loosen and remove the tip, clean the exposed end of the shutoff stem and the white gasket in the center of the tip.

If leak continues, replace the tip, the gasket can not be replaced separately.

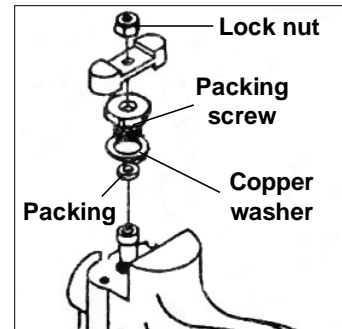
P. Leaking occurs at the back of the valve.

S. Loosen the lock nut (1/4 turn) at the back of the gun – this will re-set the shutoff stem to the gasket in the tip.

If leak continues, the packing screw may have to be removed and the packing replaced.
